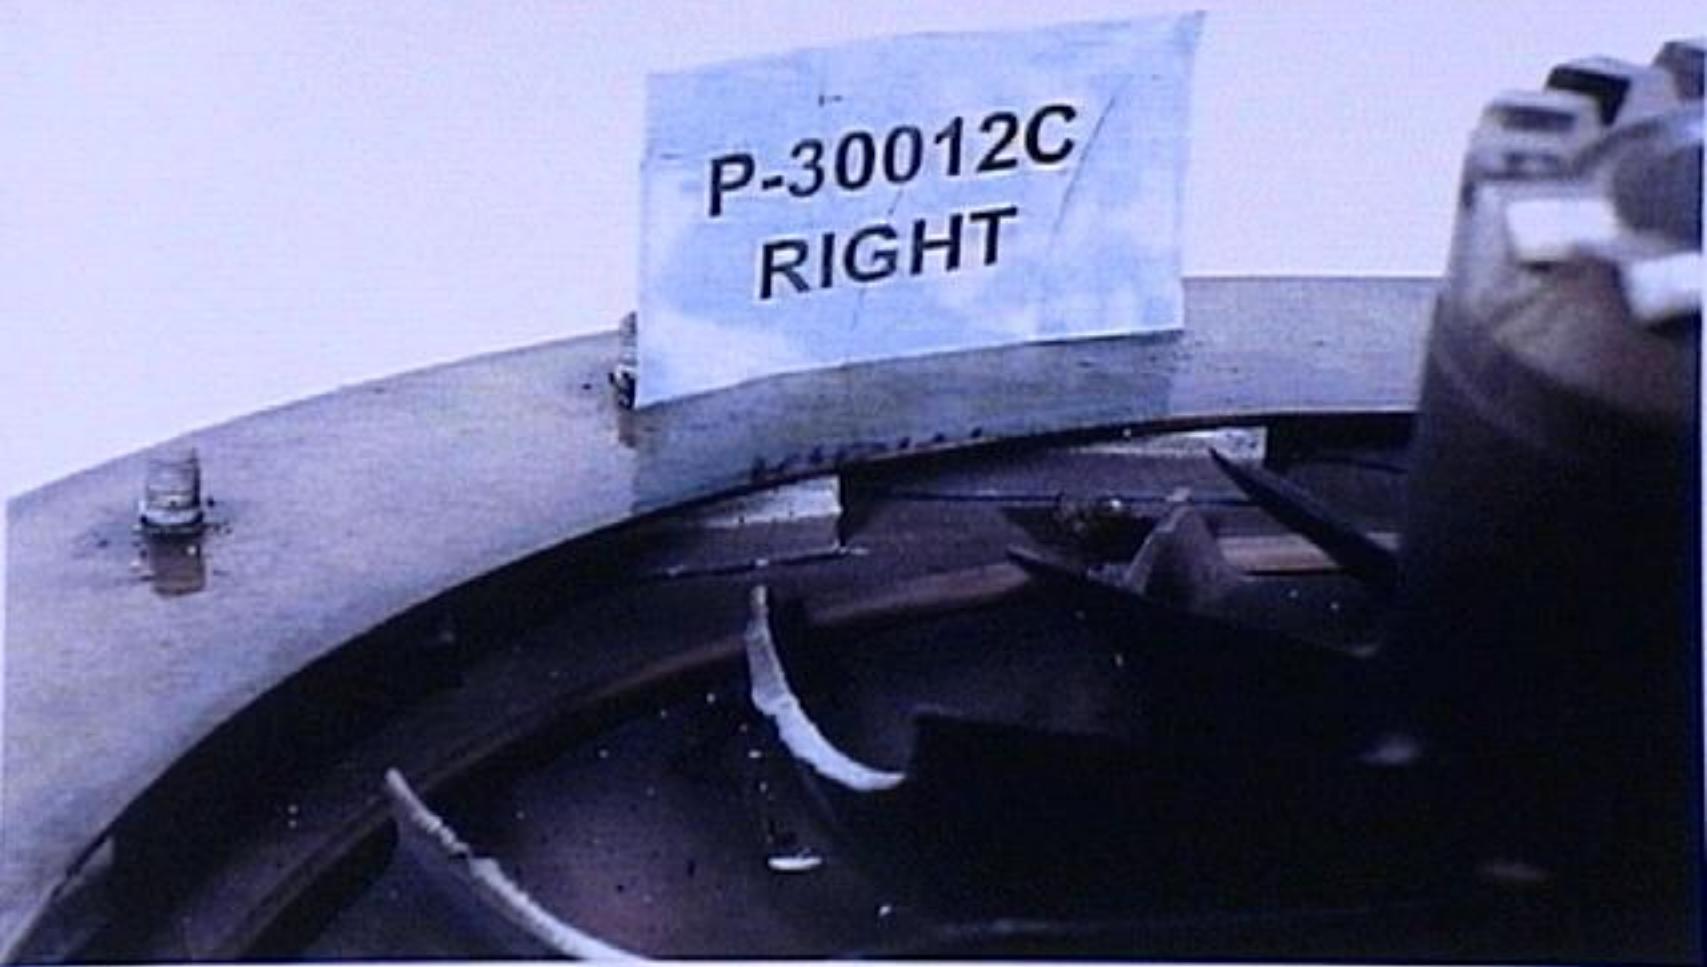
Figure 116. Metallic Particles on Second-Stage Diffuser Vanes
